CR 84.031

EVALUATIONS OF HRI FACILITIES AT NS MAYPORT AND NAS JACKSONVILLE,
FLORIDA—LESSONS LEARNED REPORT

July 1984

An Investigation Conducted by:
SYSTECH CORPORATION
245 North Valley Road
Xenia, OH 45385

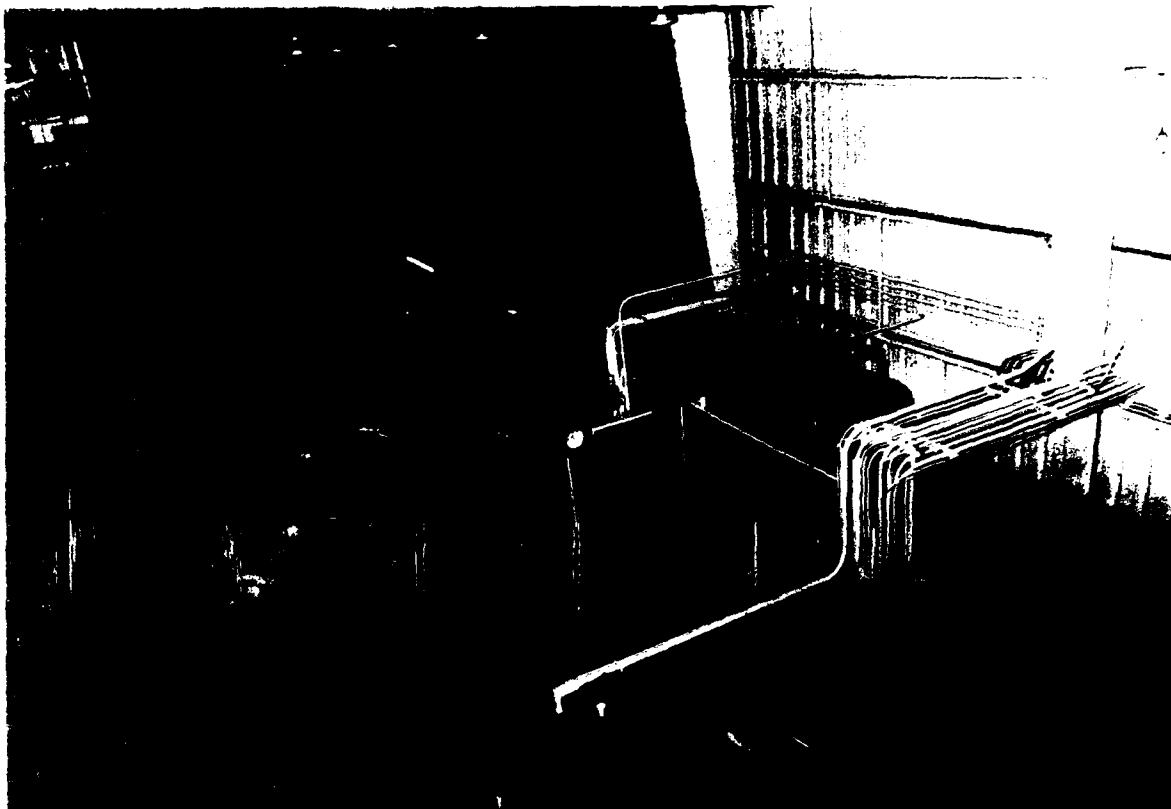
Figure 10. View of waste overflow into incinerator control panel area at NAS Jacksonville.

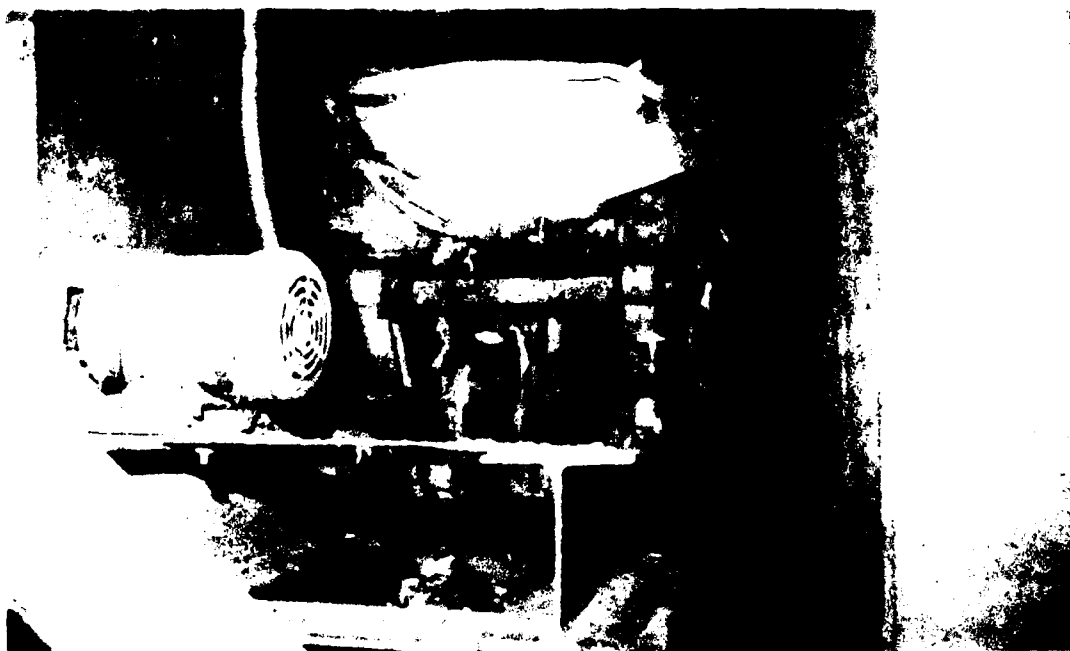
Figure 13. View of small vibrating conveyor beneath flail mill at NAS Jacksonville.

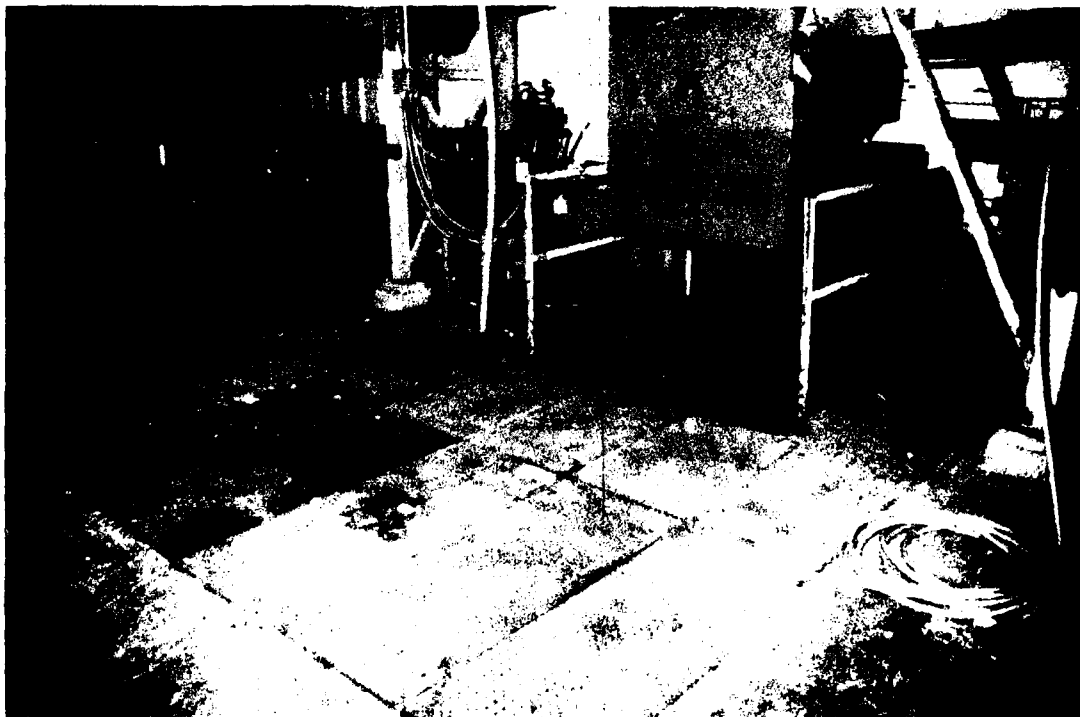
The incinerator feed system for each incinerator consists of a hydraulically actuated ram/feeder-hopper assembly. Each assembly is situated just inside the building in a 15 1/2- x 10- x 7 1/2-ft pit along with the hydraulic power unit and automatic control limit switches, while incinerators are located outside the building. The ram is actuated by two hydraulic cylinders, each having a 55-in. stroke, acting in series for a total ram travel length of 109 in. This puts the ram through an opening in the wall of the building and 38 in. into the primary chamber of the HRI during the charge cycle. The feed hopper has a 3-yd³ capacity. A flanged lid to the hopper is opened by a single hydraulic cylinder mounted on one side. A guillotine type fire door separates the loader compartment from the primary chamber. Its vertical movement is hydraulically actuated by a single cylinder mounted on the back of the door. The fire door is refractory lined with angle iron across the bottom to seal it. Access to the pit is obtained by lifting several metal floor panels, each weighing an estimated 300 lb (Figure 17).

Figure 17. View of heavy, removable panels over the loading hopper pit at NAS Jacksonville. Hydraulic unit located in the center has been relocated from the pit.
